NOTIFICATION OF ENVIRONMENTAL CONCERN (NOEC) INVESTIGATION REPORT

NOTIFICATION NUMBER 021221-NH-0845				NDEQ ID / Program ID 84069	
INSPECTOR Mark Pomajzl					
INSPECTION DATE 2-14-2021	TIME/ARRIVAL 10:00am	TIME/DEPARTURE 10:30am	WEATHER Clear		TEMP 2F
PROBLEM LOCATION			<input checked="" type="checkbox"/> Same as NEC Problem Location		
NAME Scott Tingelhoff				PROGRAM ID # 84069	
POSITION/TITLE General Manager					
BUSINESS NAME AltEn, LLC					
ADDRESS 1344 County Road 10		CITY Mead	COUNTY Saunders	STATE NE	ZIP CODE 68041
QUARTER N1/2, SW1/4	SECTION 12	TOWNSHIP N 14		RANGE E 8	
DIRECTIONS TO SITE From Airport, Highway 92/77 (Rd M) -3E, Rd 13-0.75, W Side		LATITUDE 41.19714		LONGITUDE -96.48081	
RESPONSIBLE PARTY			<input checked="" type="checkbox"/> Same as NEC Responsible Party		
NAME Scott Tingelhoff				PROGRAM ID # 84069	
POSITION/TITLE General Manager					
BUSINESS NAME AltEn, LLC					
ADDRESS 1344 County Road 10		CITY Mead	COUNTY Saunders	STATE NE	ZIP CODE 68041

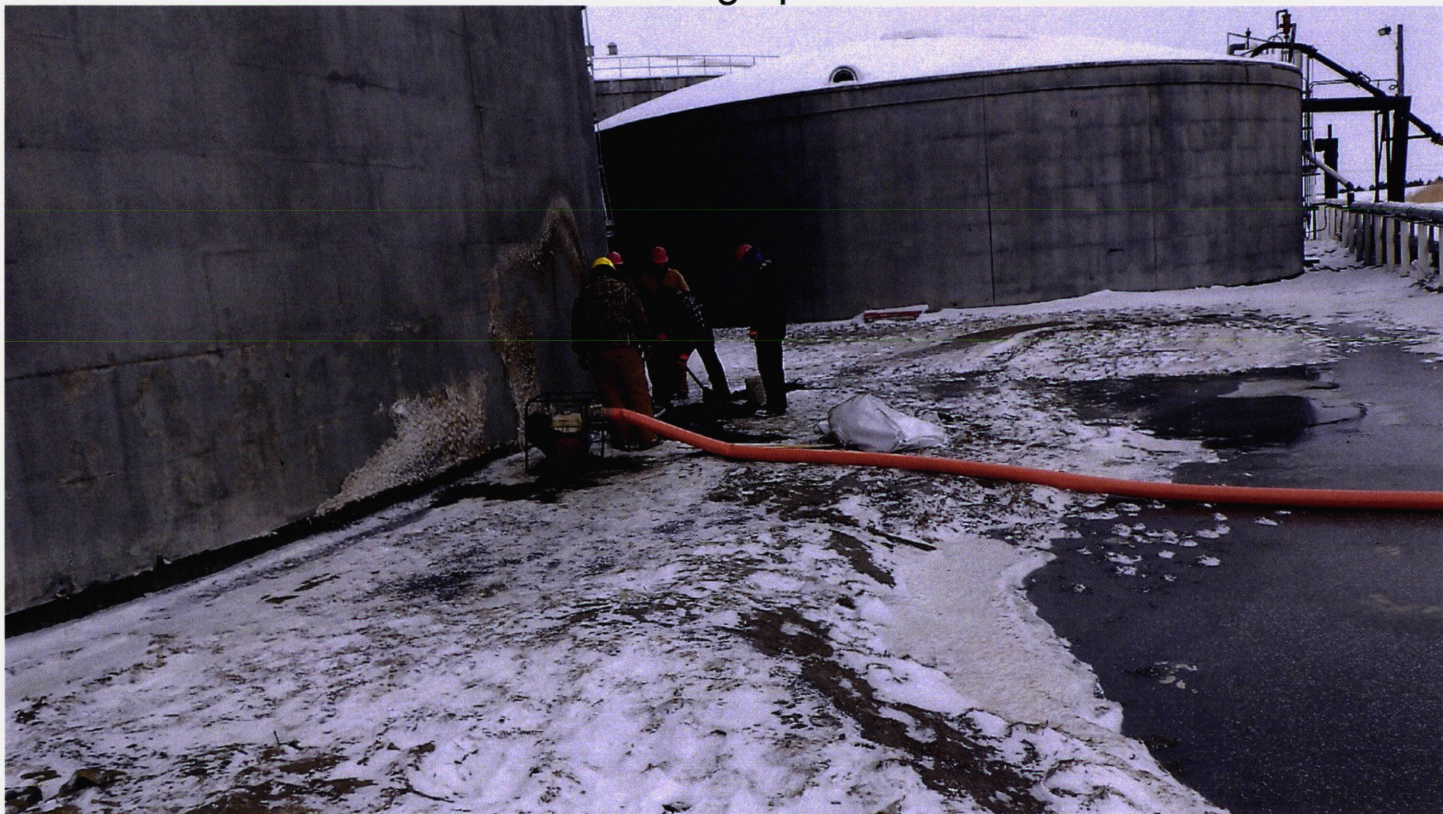
Photo 1

Upon arrival, I noted that the area east of the digester was significantly lower than before. I briefly spoke to Mr. Peterson who was about to leave. I stated I was just there to document the digester. Mr. Peterson granted me access and then went to buy supplies. I was able to walk to the broken pipe, photo 1. There was no one onsite to confirm, but it appears the digester is empty. The facility has not installed storm water controls or spill response measures to mitigate the spill. I then walked around the digester and noted the north digester had developed a large icicle, photo 2. The icicle covers the valve and piping system. I did email Mr. Tingelhoff of the icicle for information purposes. AltEn installed caution tape below the icicle. Mr. Egr stated Saturday that the north digester pipes are now protected by heat lamp, heat tape and foam insulation.

Location: South digester

Description: The photo depicts workers making repairs. The facility is pumping wastewater into the emergency lagoon.

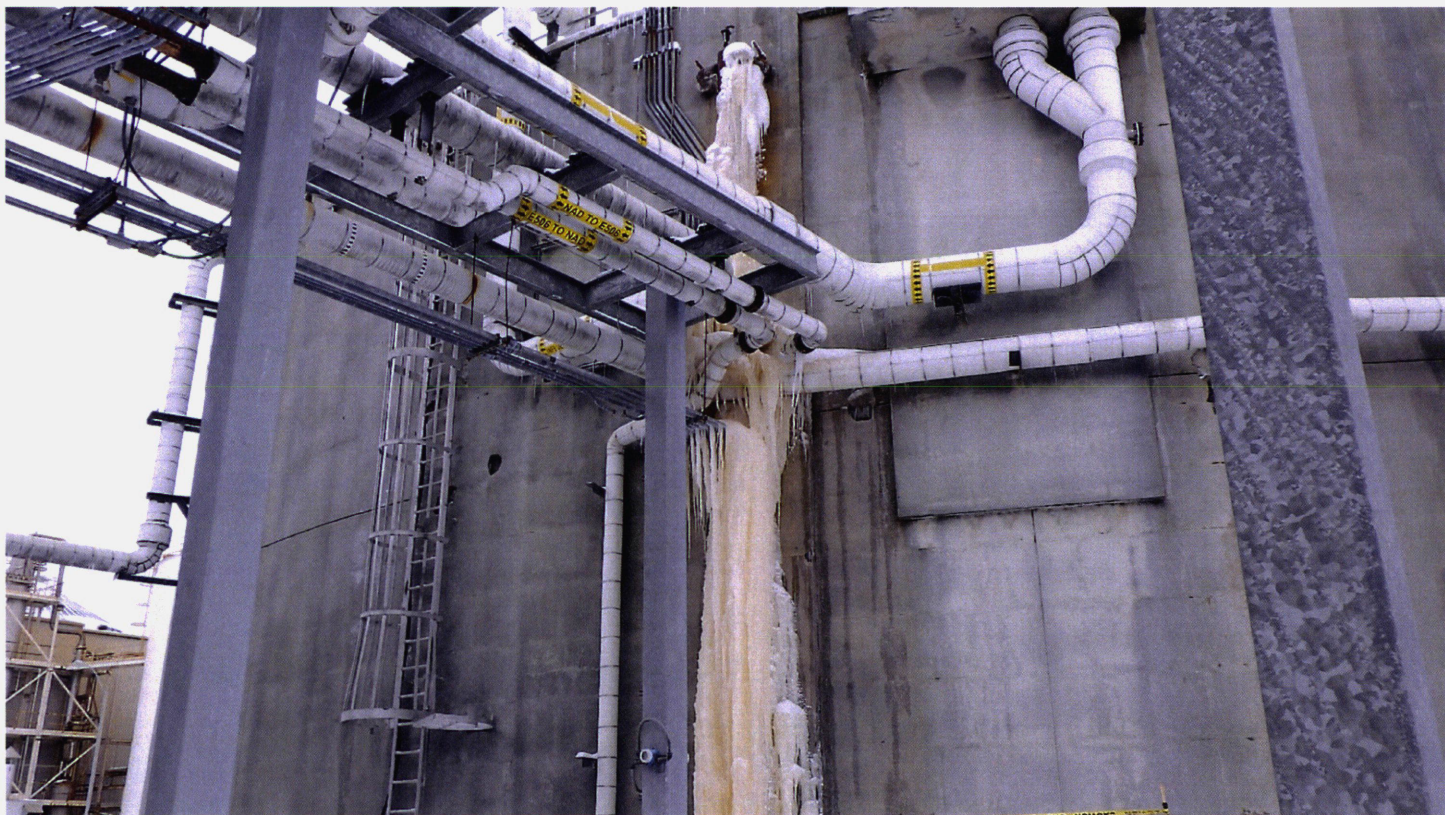
Photo 2

Location: North digester

Description: The photo depicts a leak forming a large icicle on the north digester. AltEn is aware that it is there.

I was onsite Saturday and today (Sunday). Both days I noticed a small but consistent water leak from the north digester. I know you and your team are aware of the icicle it has formed since it is blocked off with tape, see photo. The question is, could this cause valve or piping failure? I was just concerned of the way it looked this morning and wanted to give you a heads up. It would be a good idea to investigate that leak especially during this extreme cold temperatures.

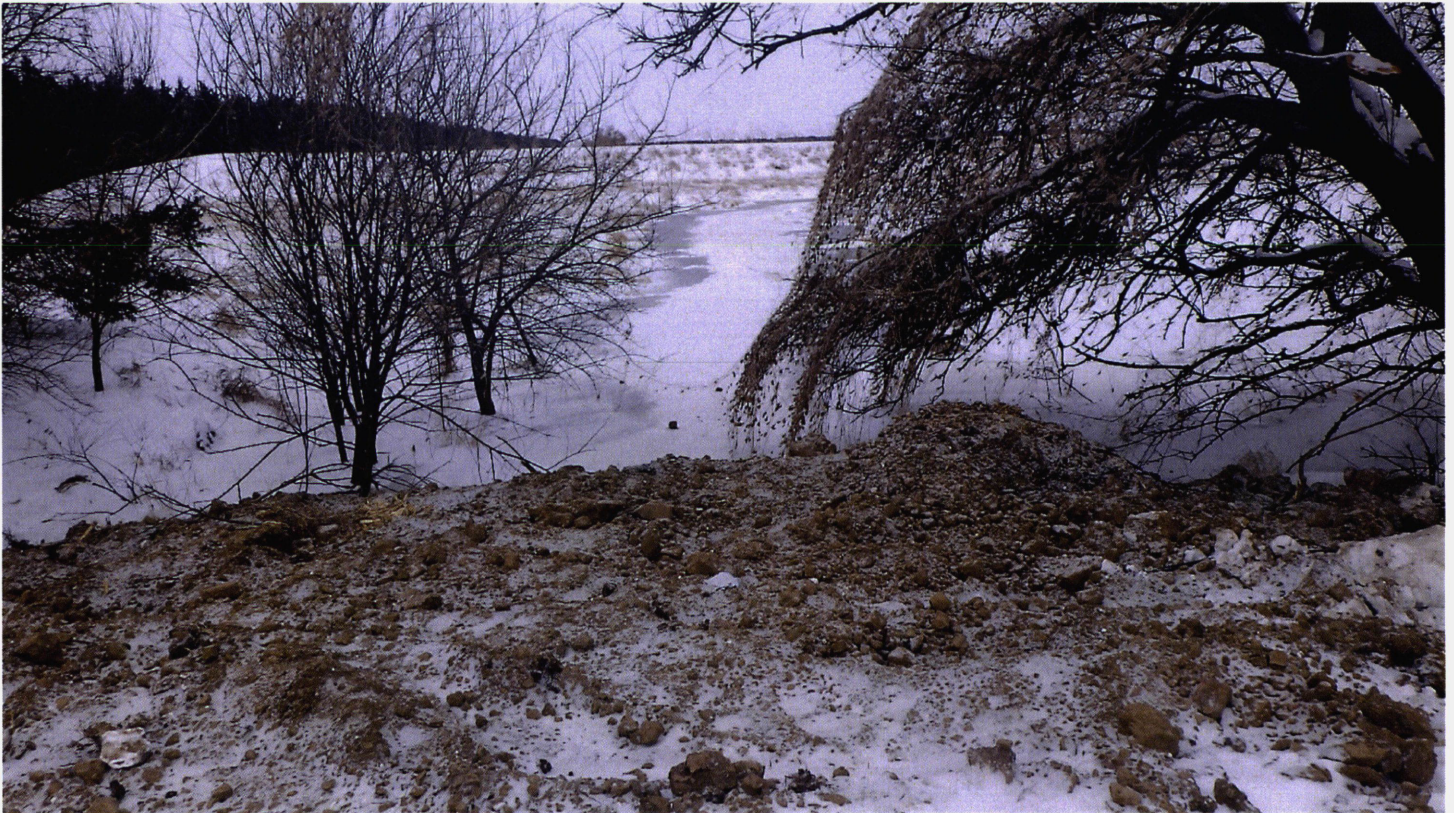
Photo 3

I then investigated the southeast culvert/outfall 001, photo 3. There was no one onsite so I inspected the structure. I observed that water continues to flow through the makeshift dam, photo 4. I did not inspect the spill on University of Nebraska – Lincoln UNL property.

Location: Southeast culvert

Description: The photo depicts the makeshift dam. The dam is larger than observed on Saturday.

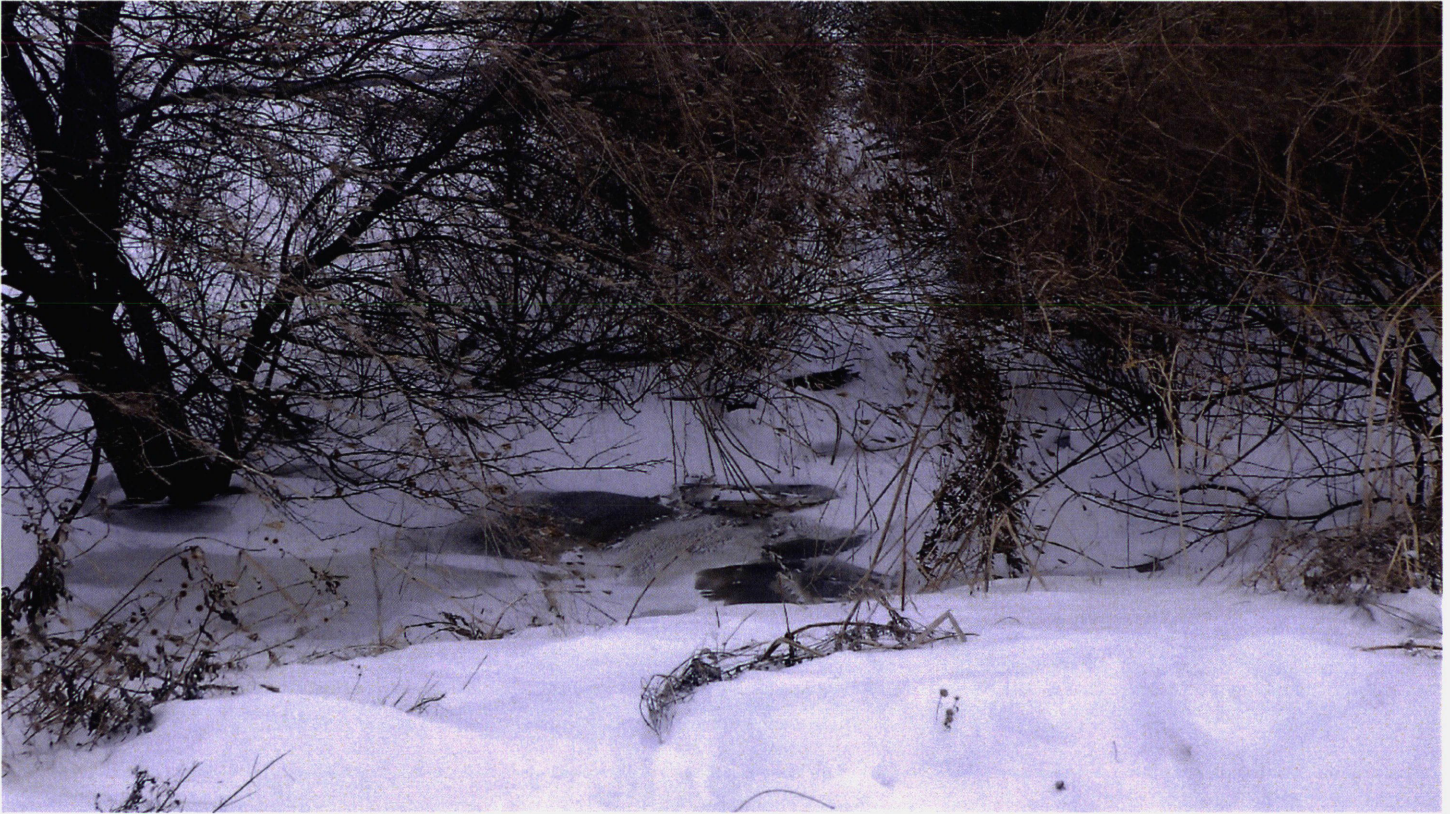
Photo 4

Location: Southeast culvert

Description: The photo depicts flow exiting the east side of the culvert.
