May 19, 2021

Sewer Force Main Leak Inspection
Alten, LLC Ethanol Production Facility
W 1/2 of Sec. 12, T 14N, R 8E, Saunders County

SEWER LEAK INSPECTION

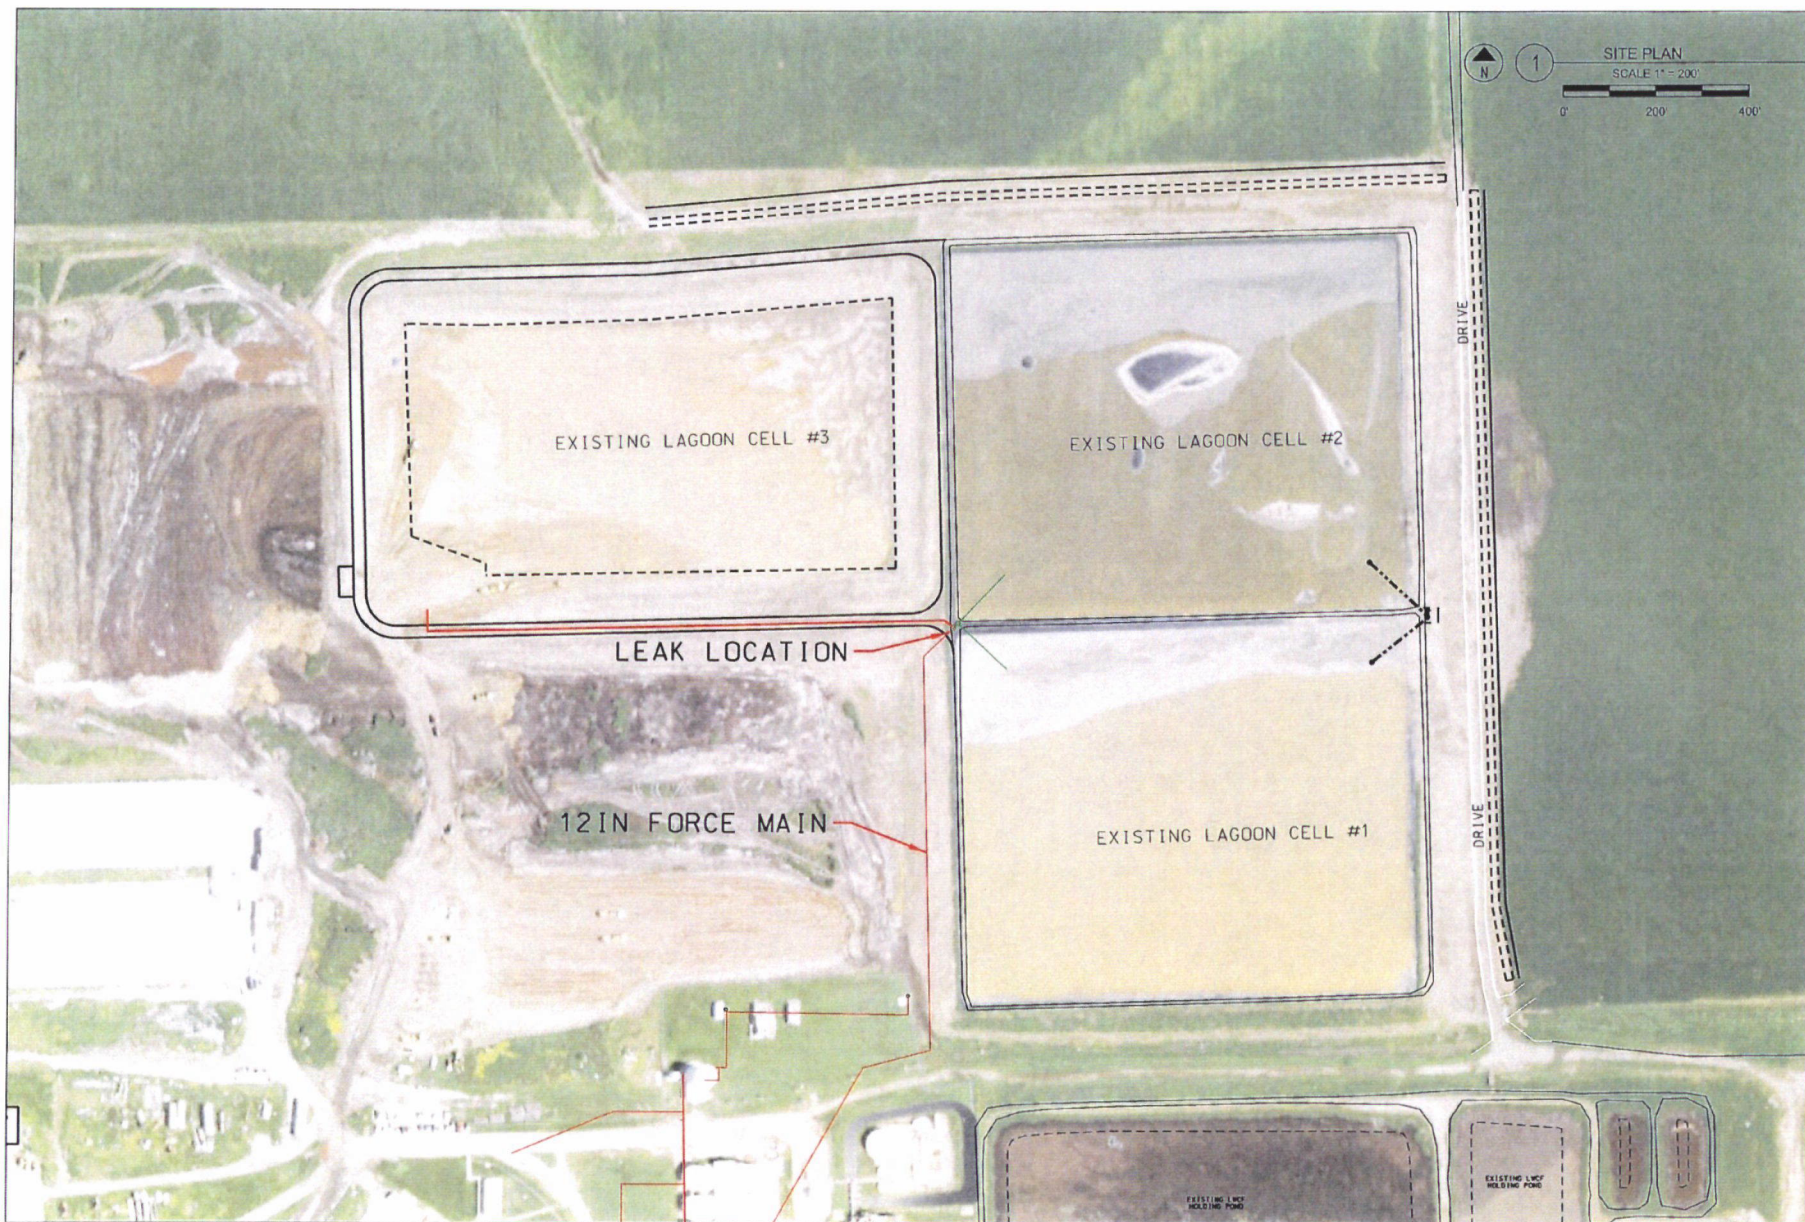
On May 13, 2021, I met Mr. Matthew O'brien at the facility referenced above. He showed me to the location where sewer discharge had been visually observed "bubbling" to the surface in the west embankment of Lagoon Cell #1. It was located just south of the two concrete manholes that serve as junction points and house valves to allow for flow to be directed to each lagoon. After reviewing the plans, we concluded that the leak was in the 12 inch sewer force main that flows from the lift station adjacent to the plant up to the two manhole junction points. The grade was observed to be soft and disturbed at the surface.

Please find enclosed a site plan showing the location of the observed leak as well as photos showing the probing locations. The lath shows the location that the surface disturbance was noted. The flags indicate the location that stable subgrade was observed in each direction from the leak. Please contact us with any questions or concerns.

must be repaired prior to any further operation or the facility will risk further subgrade damage and a potential future breach as the result.

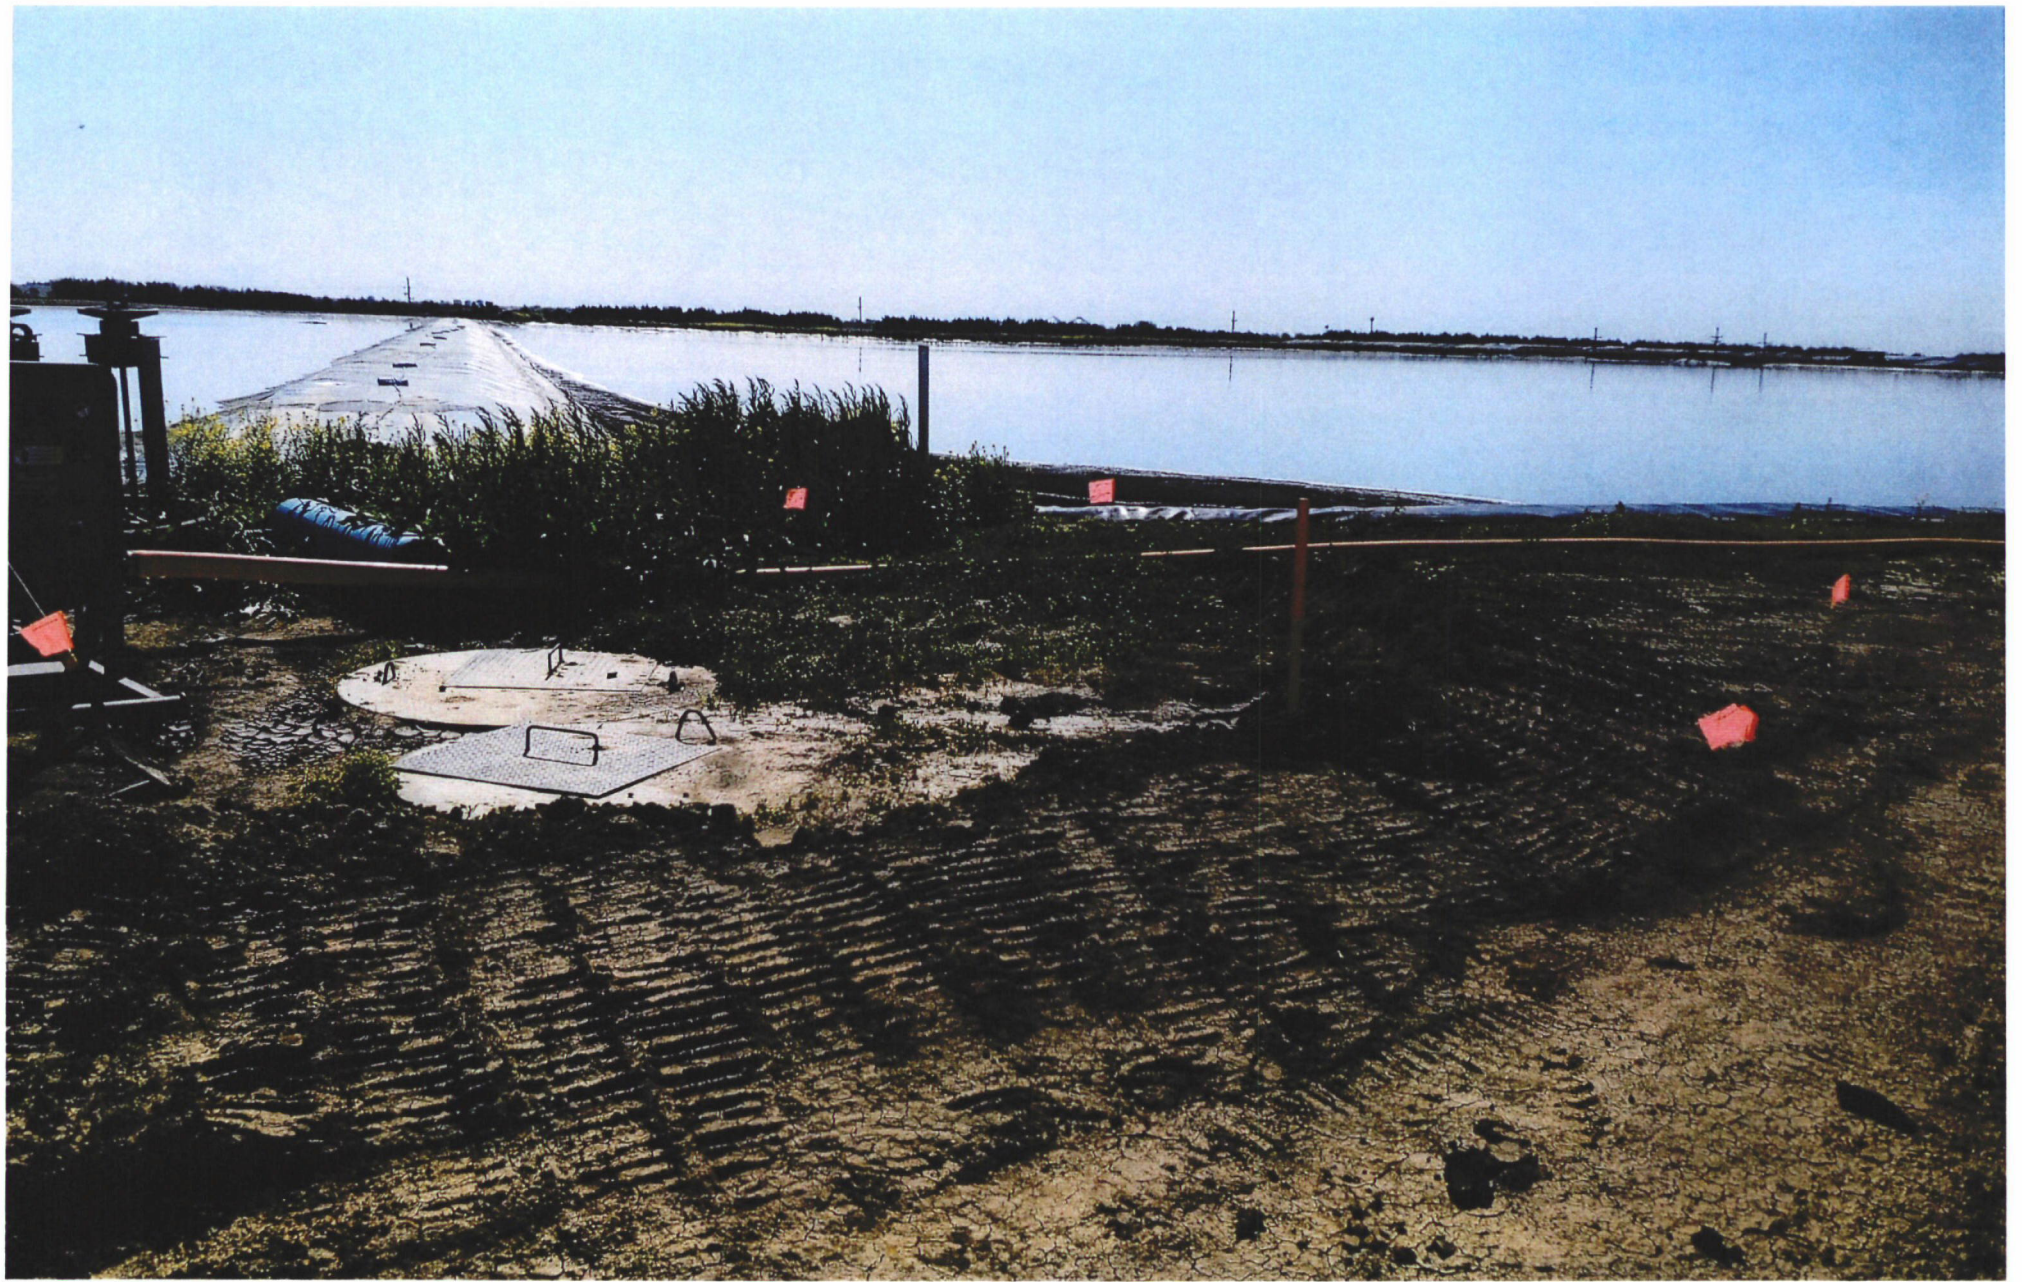
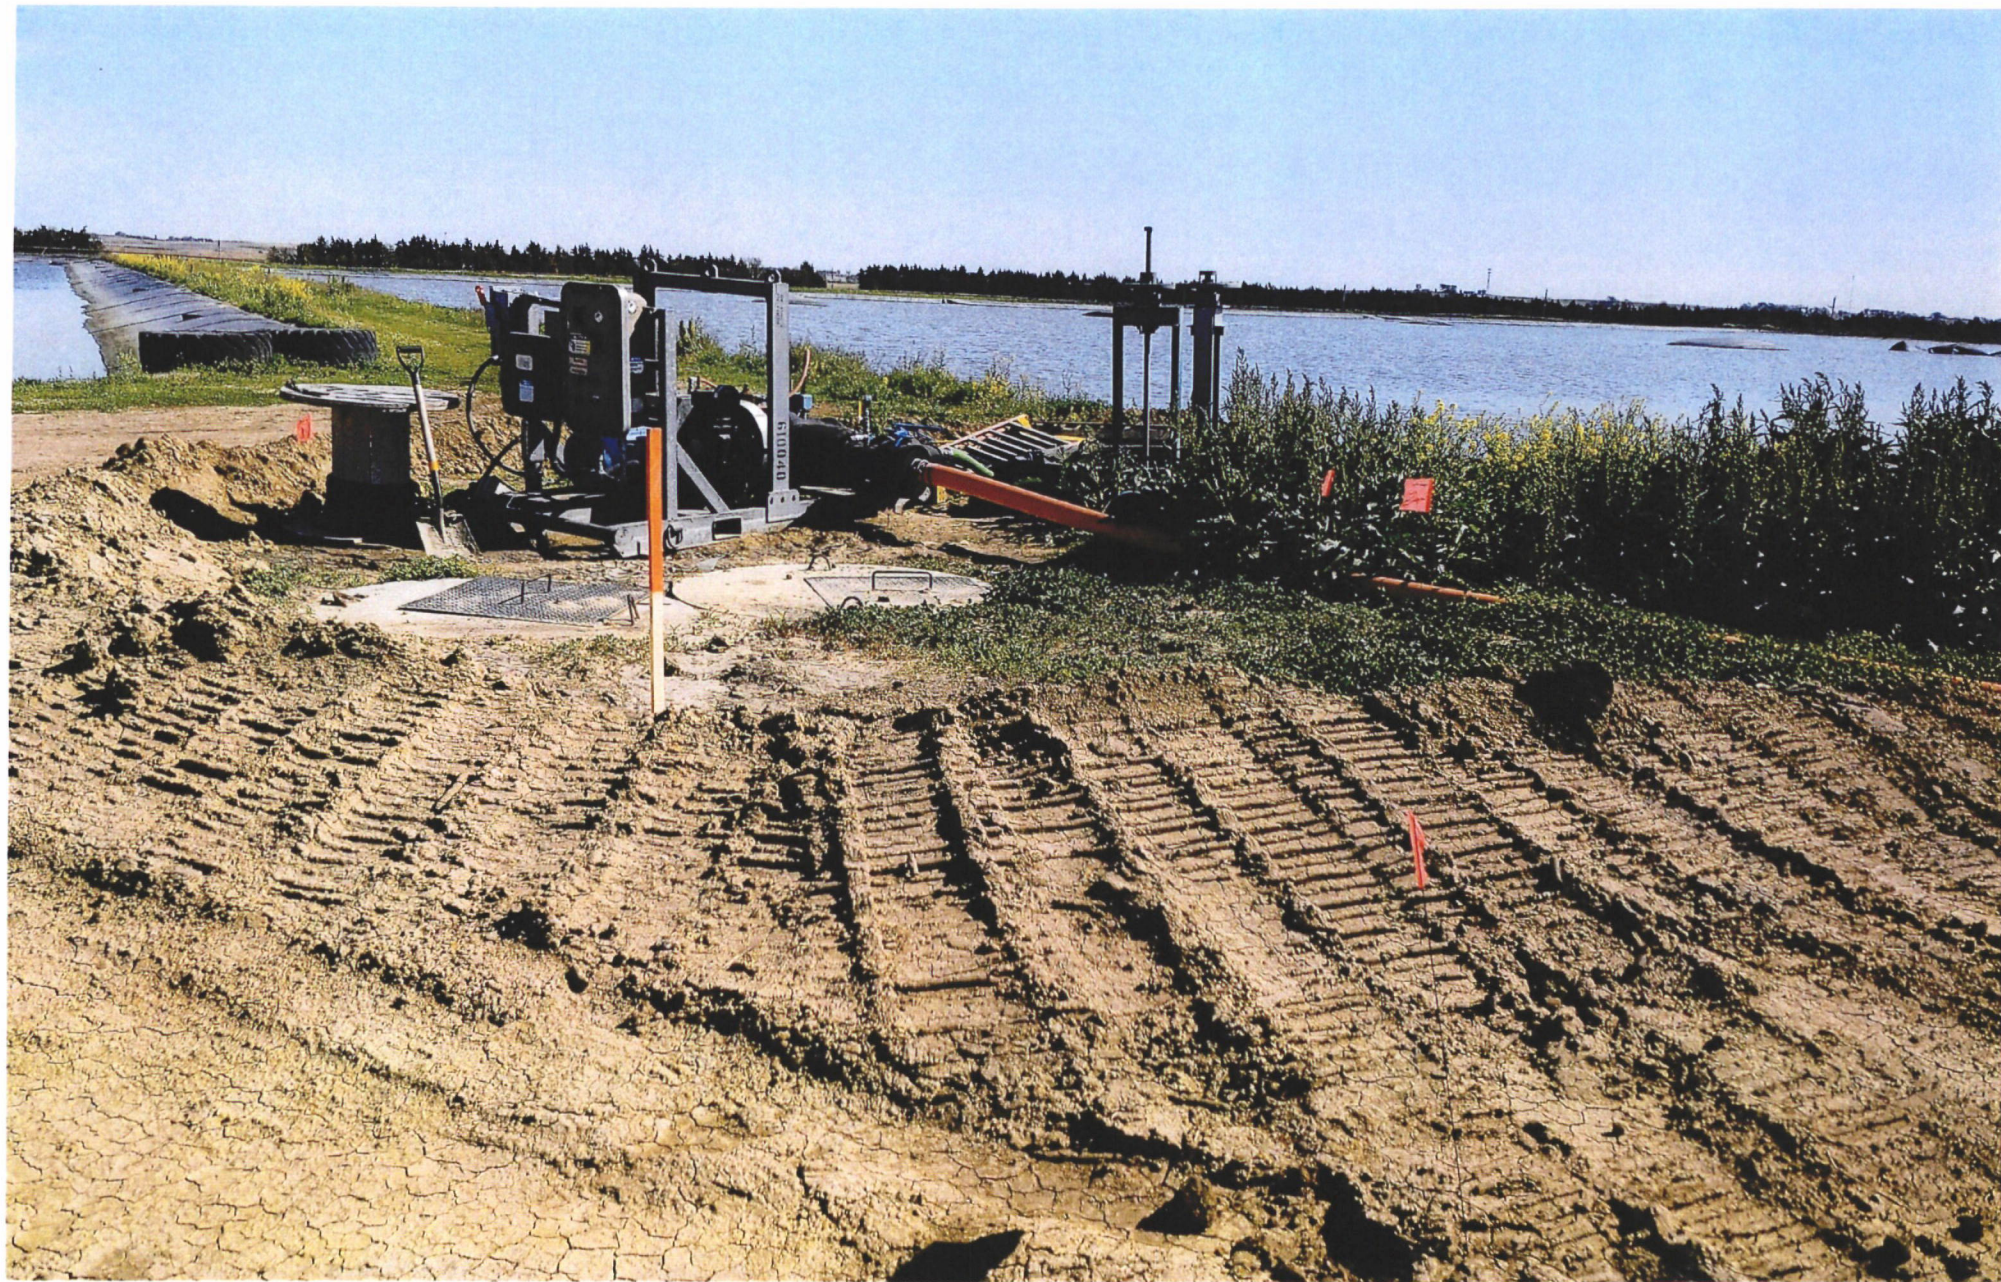
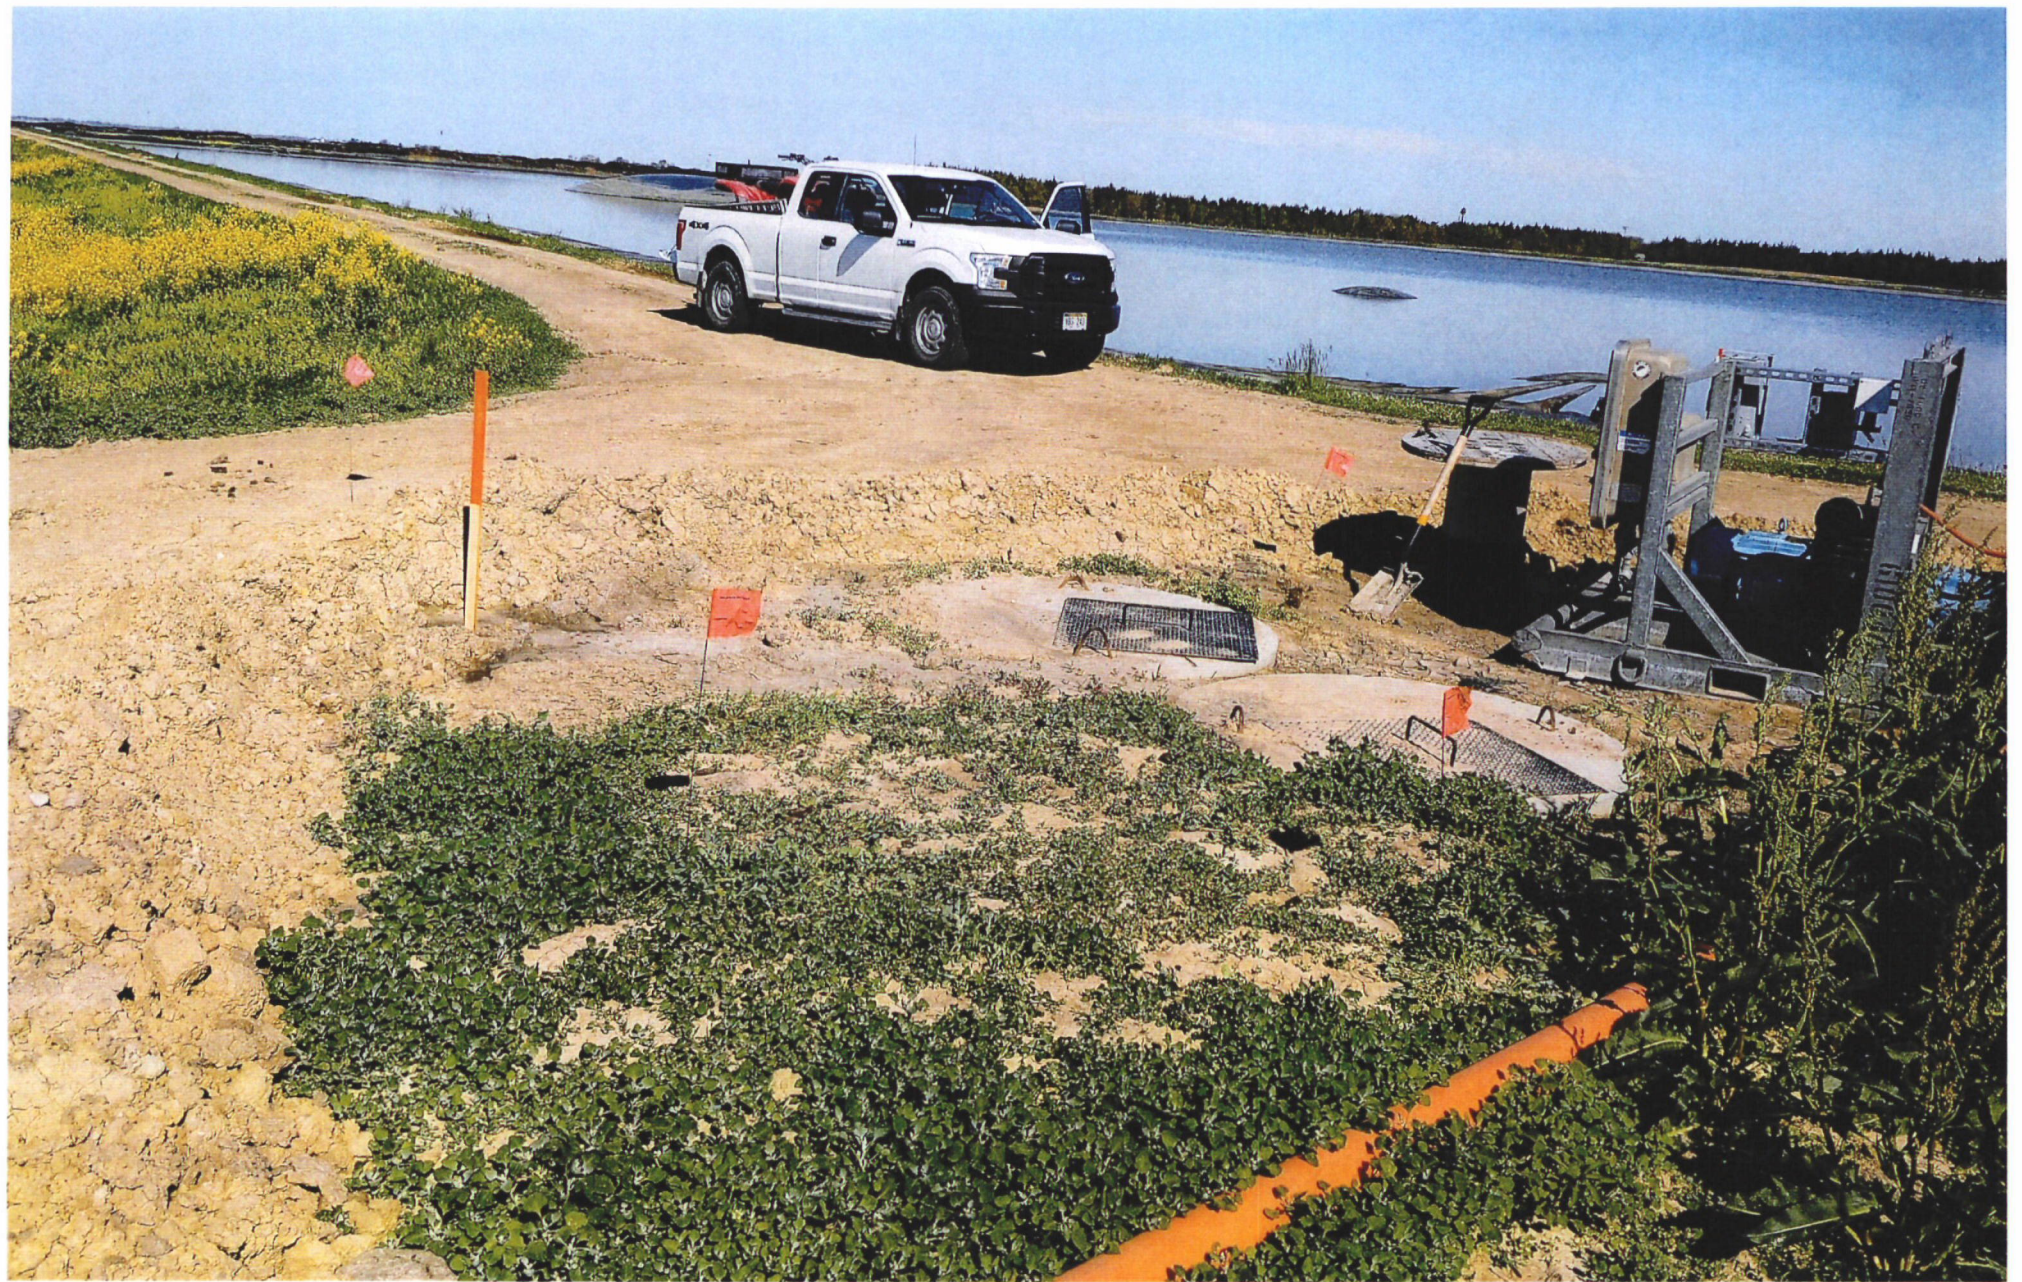
A hand operated steel sampling probe was used to probe at the location where surface disturbance was observed. Little to no resistance was felt at that location to a depth of approximately 3.5 feet indicating that a void had been created from the leak. Saturated soft subgrade was observed from 3.5 to 4.0 feet below the surface. Probing was then done in a pattern around the initial site moving radially outward until structurally stable subgrade was encountered. In this way the extent of the damage created from the leak was delineated. The distance from the initial spot to stable subgrade was measured and varied from a minimum of 6 feet up to a maximum of 10 feet. The distance from the permanent impoundment pool in Lagoon Cell #1 to the closest probing that found stable subgrade was also measured and showed that a minimum of 20 feet of stable subgrade remained.
