RE: Site Investigation Report
AltEn, LLC
1344 County Road 10
Mead, NE 68041

NDEQ ID: 84069

Program ID: NE0204447 (IWM)

NEC #: 041018-AB-1328

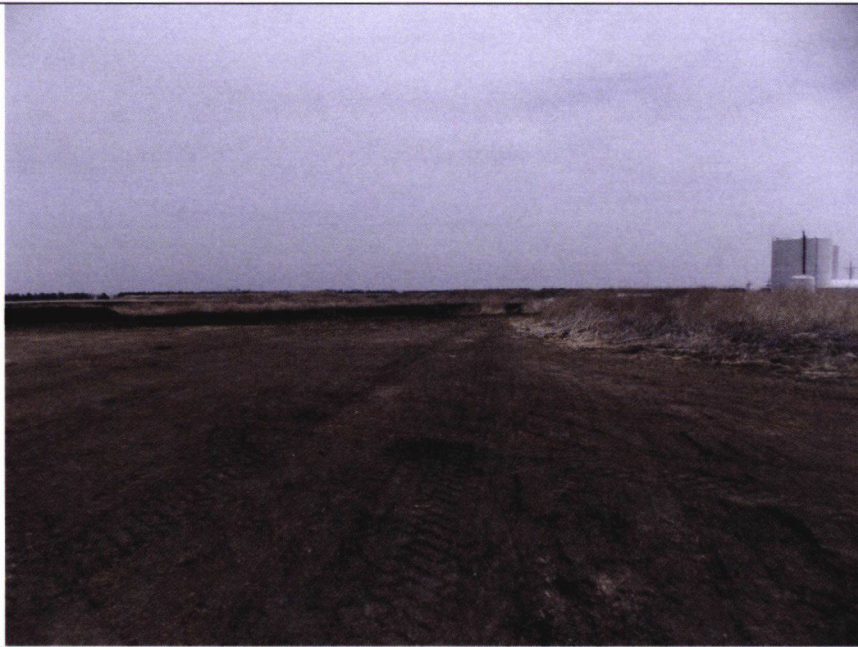
Photograph 1
Date: April 12, 2018
Photographer: Jason Holsten
Camera: Nikon Coolpix L810
IIS# 84069, IWM Permit # NE0204447
NEC# 041018-AB-1328
Subject: AltEn, LLC Site Investigation

Looking east, photograph showing an area located north of the office building where wet distiller's grain (WDG) was previously being stored. Photograph taken to show progress made by facility in removing the material.

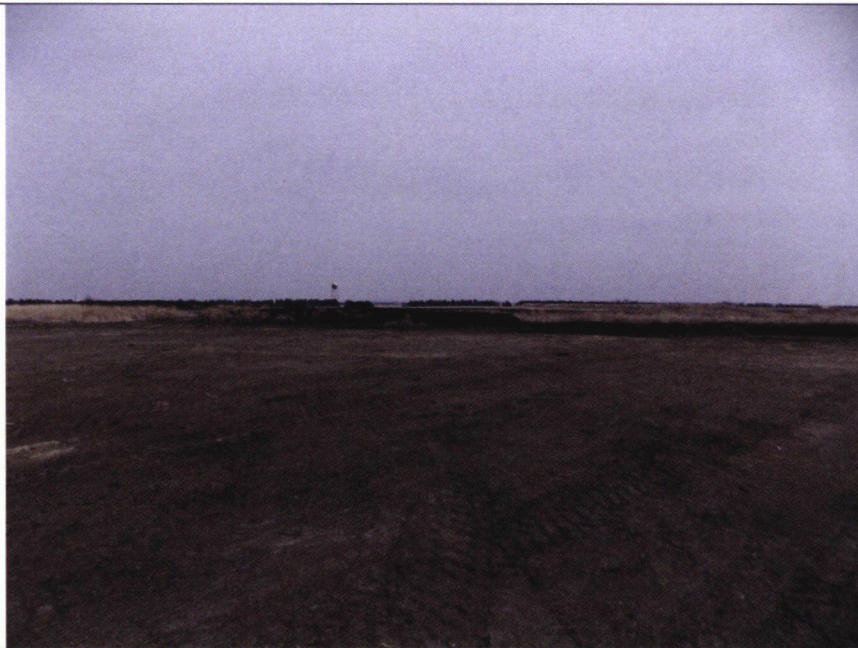
Photograph 2
Date: April 12, 2018
Photographer: Jason Holsten
Camera: Nikon Coolpix L810
IIS# 84069, IWM Permit # NE0204447
NEC# 041018-AB-1328
Subject: AltEn, LLC Site Investigation

Looking north from the same vantage point as the previous photograph. Photograph taken to show the amount of material that has been removed from the site.

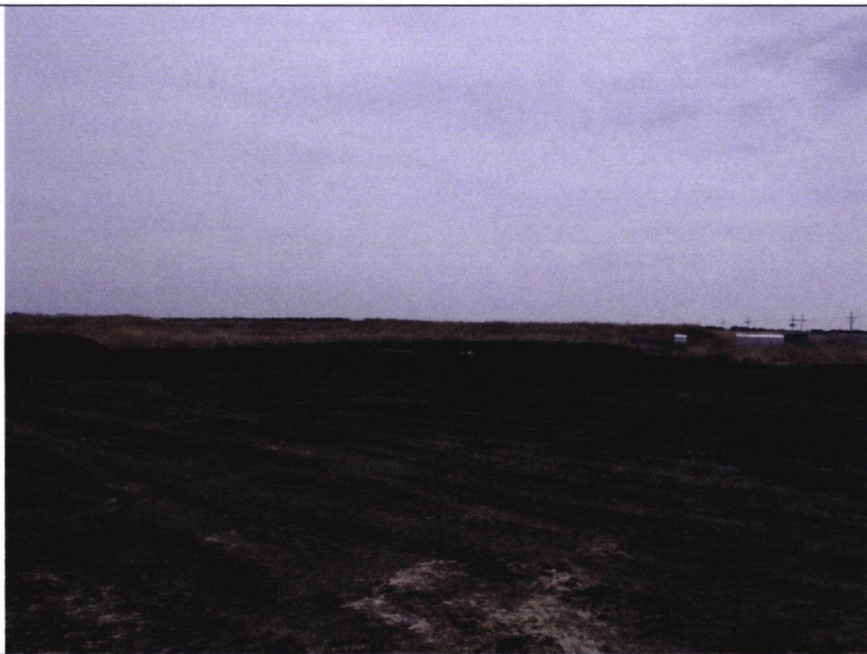
Photograph 3
Date: April 12, 2018
Photographer: Jason Holsten
Camera: Nikon Coolpix L810
IIS# 84069, IWM Permit # NE0204447
NEC# 041018-AB-1328
Subject: AltEn, LLC Site Investigation

Looking northeast, photograph showing material that has settled over time. Mr. Stewart explained that over time the material settles and is not as voluminous as before.

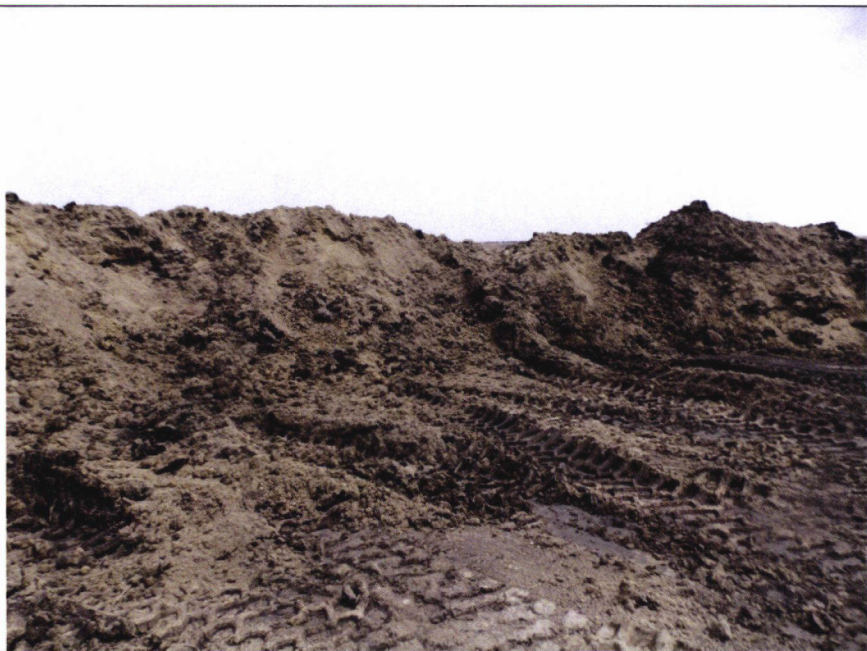
Photograph 4
Date: April 12, 2018
Photographer: Jason Holsten
Camera: Nikon Coolpix L810
IIS# 84069, IWM Permit # NE0204447
NEC# 041018-AB-1328
Subject: AltEn, LLC Site Investigation

Photograph showing a closer view of the material. Mr. Stewart said this material had been turned and mixed with newer material in order for it to dry before processing through the Biochar process. He also said color of the material can vary depending on the dye color of the seed corn being processed through the ethanol plant.

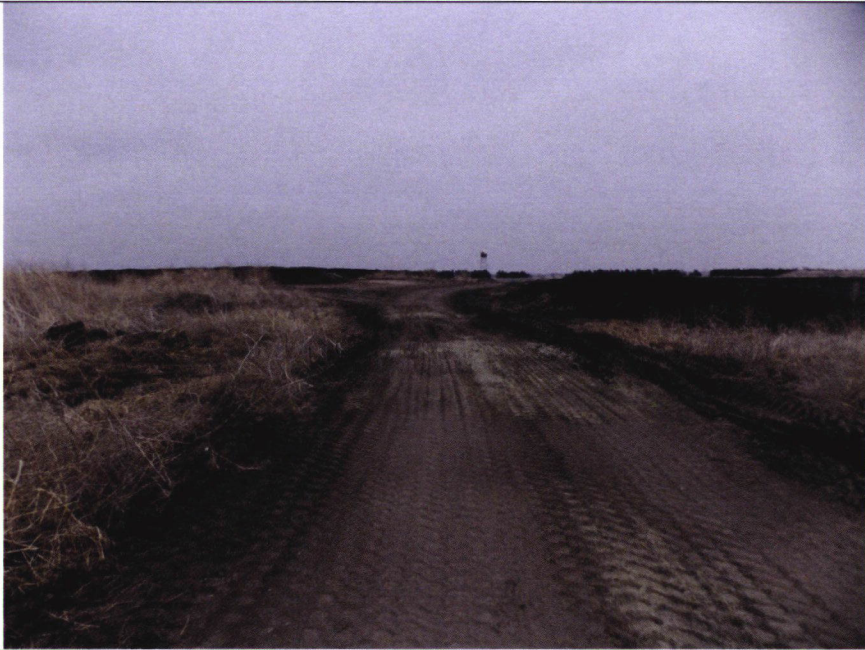
Photograph 5
Date: April 12, 2018
Photographer: Jason Holsten
Camera: Nikon Coolpix L810
IIS# 84069, IWM Permit # NE0204447
NEC# 041018-AB-1328
Subject: AltEn, LLC Site Investigation

Looking north, photograph showing additional material being stored on site. Mr. Stewart said the material located in the upper left corner of the photograph was newer material.

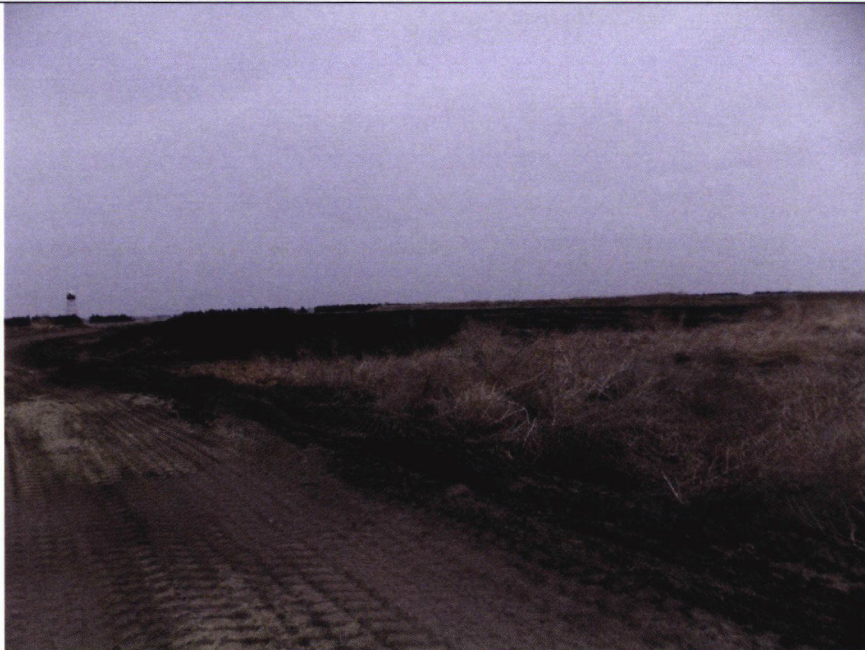
Photograph 6
Date: April 12, 2018
Photographer: Jason Holsten
Camera: Nikon Coolpix L810
IIS# 84069, IWM Permit # NE0204447
NEC# 041018-AB-1328
Subject: AltEn, LLC Site Investigation

Looking north northeast, photograph showing additional material being stored on site.

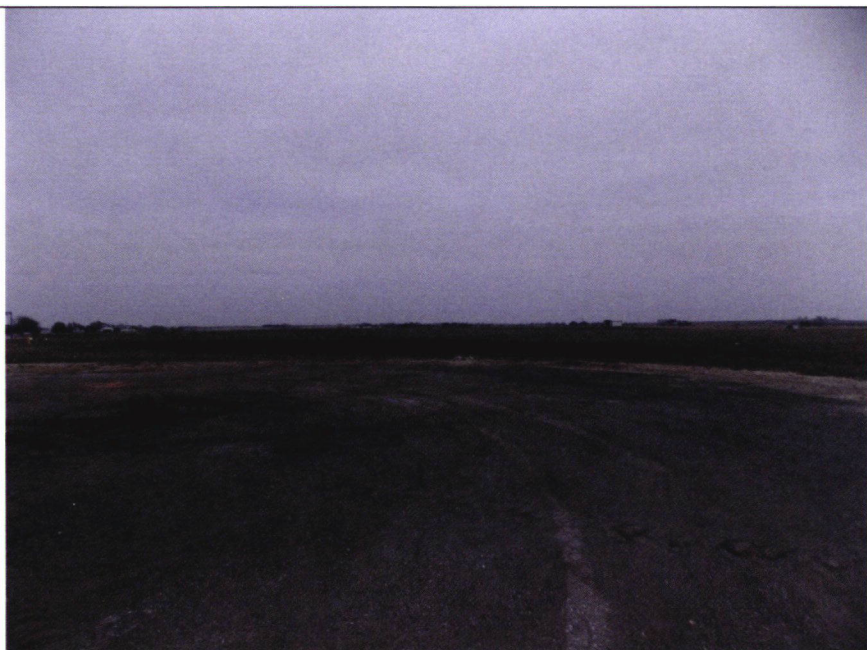
Photograph 7
Date: April 12, 2018
Photographer: Jason Holsten
Camera: Nikon Coolpix L810
IIS# 84069, IWM Permit # NE0204447
NEC# 041018-AB-1328
Subject: AltEn, LLC Site Investigation

Looking east northeast, photograph of the field identified as "A" on the Google Earth image (Attachment V).

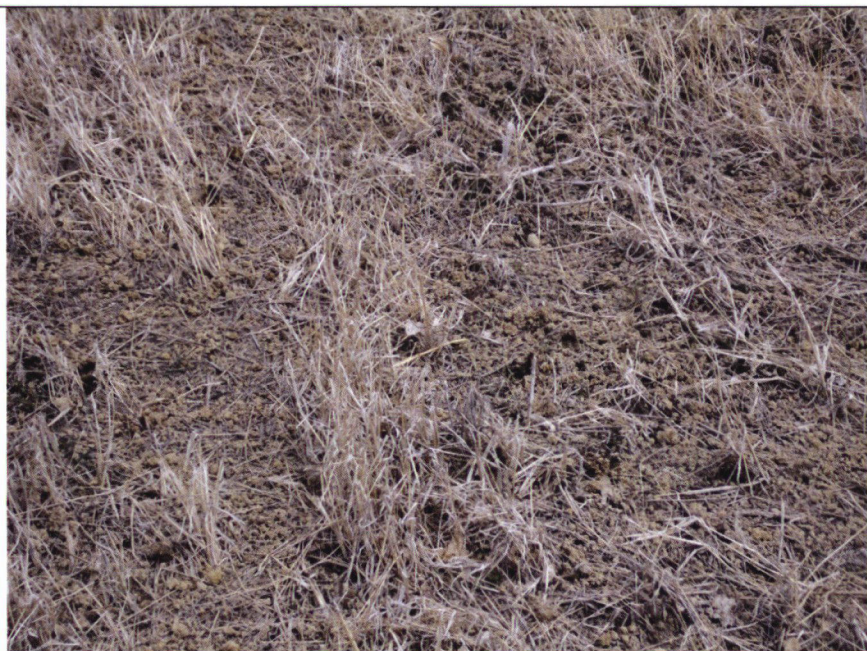
Photograph 8
Date: April 12, 2018
Photographer: Jason Holsten
Camera: Nikon Coolpix L810
IIS# 84069, IWM Permit # NE0204447
NEC# 041018-AB-1328
Subject: AltEn, LLC Site Investigation

Photograph showing a closer view of the material after being spread onto the field. This material was observed laying on a grassy edge next to the field identified as "A" on the Google Earth image.

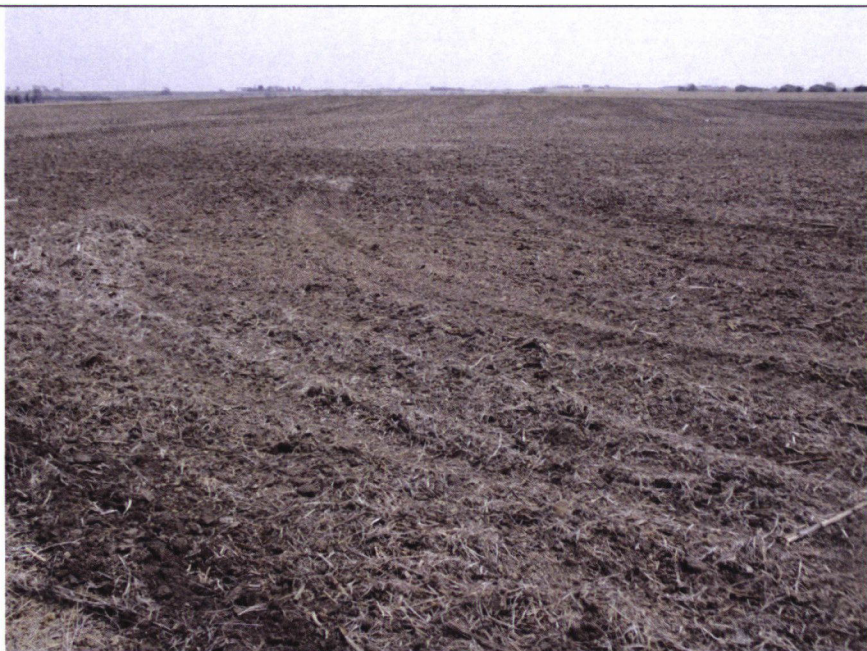
Photograph 9
Date: April 12, 2018
Photographer: Jason Holsten
Camera: Nikon Coolpix L810
IIS# 84069, IWM Permit # NE0204447
NEC# 041018-AB-1328
Subject: AltEn, LLC Site Investigation

Another photograph showing the field identified as "A" on the Google Earth image. Mr. Erg said the material had been incorporated (disked) into the soil.

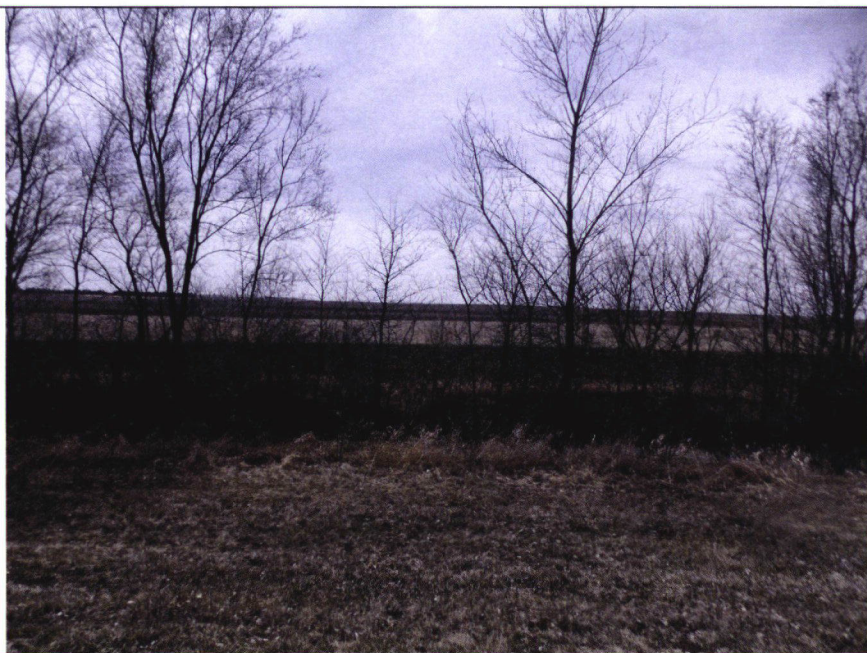
Photograph 10
Date: April 12, 2018
Photographer: Jason Holsten
Camera: Nikon Coolpix L810
IIS# 84069, IWM Permit # NE0204447
NEC# 041018-AB-1328
Subject: AltEn, LLC Site Investigation

Looking south, photograph showing the field identified as "B" on the attached Google Earth image. This was the field mentioned in NEC #041018-AB-1328. This photograph was taken while standing near the intersection of Sunburst Lane and Joyce Circle.

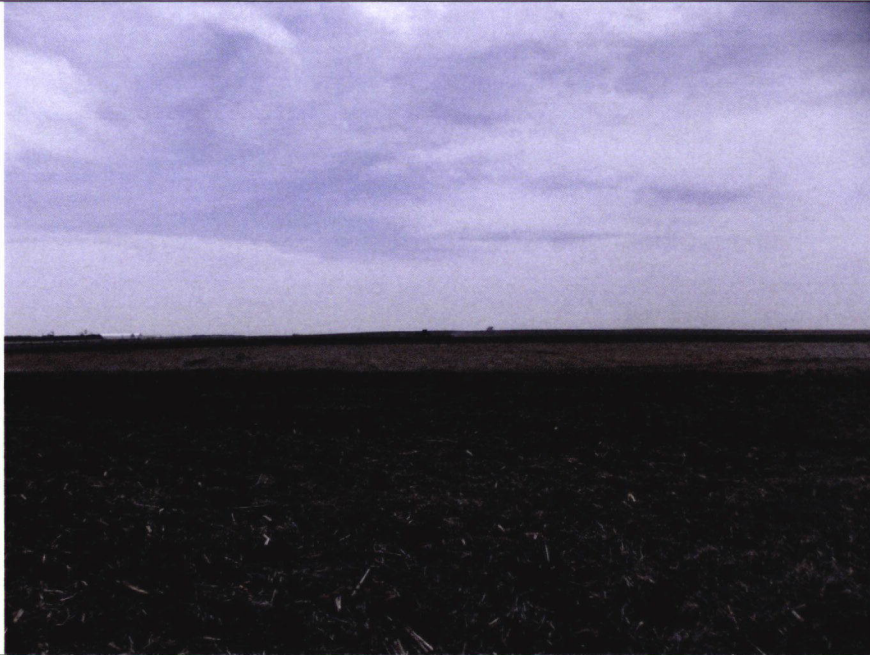
Photograph 11
Date: April 12, 2018
Photographer: Jason Holsten
Camera: Nikon Coolpix L810
IIS# 84069, IWM Permit # NE0204447
NEC# 041018-AB-1328
Subject: AltEn, LLC Site Investigation

Looking south, photograph taken to show a farmer incorporating (disking) the material into the soil on field "B."

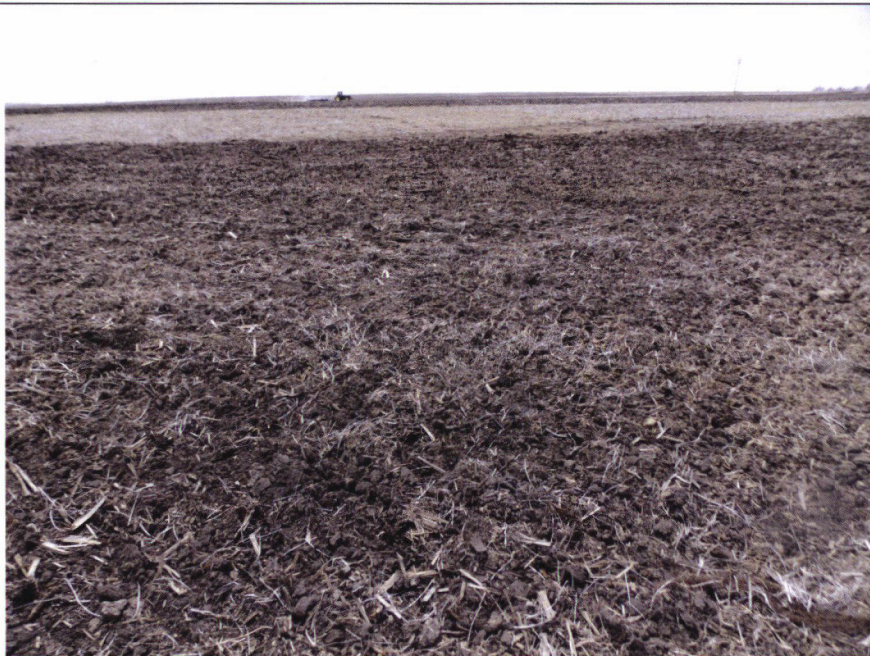
Photograph 12
Date: April 12, 2018
Photographer: Jason Holsten
Camera: Nikon Coolpix L810
IIS# 84069, IWM Permit # NE0204447
NEC# 041018-AB-1328
Subject: AltEn, LLC Site Investigation

Photograph taken to show a closer view of the portion of field "B" that had been disked to incorporate the material into the soil.

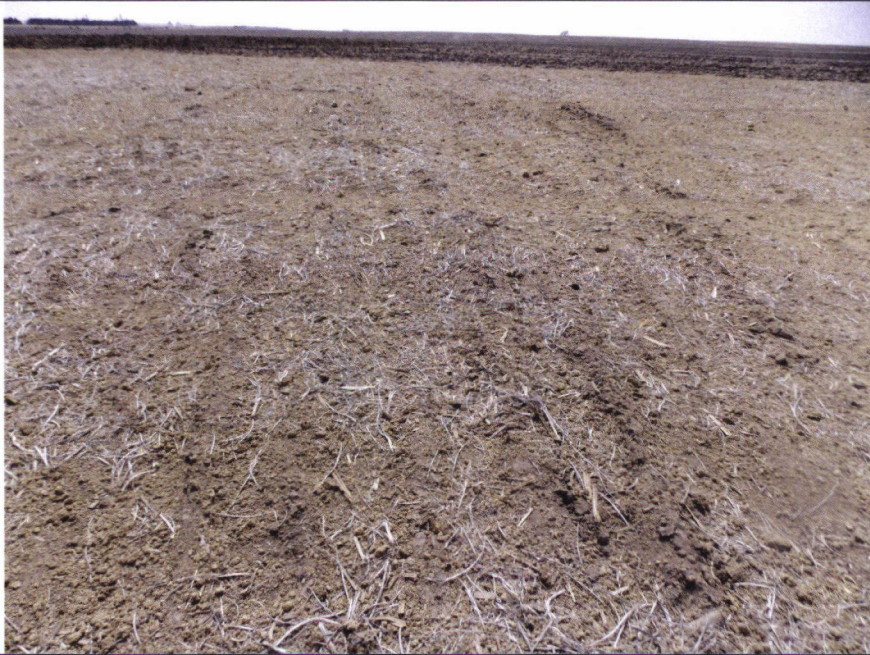
Photograph 13
Date: April 12, 2018
Photographer: Jason Holsten
Camera: Nikon Coolpix L810
IIS# 84069, IWM Permit # NE0204447
NEC# 041018-AB-1328
Subject: AltEn, LLC Site Investigation

Photograph taken to show the area of field "B" where the material had not yet been incorporated (disked) into the soil. Note the material which appears as small clumps of soil.

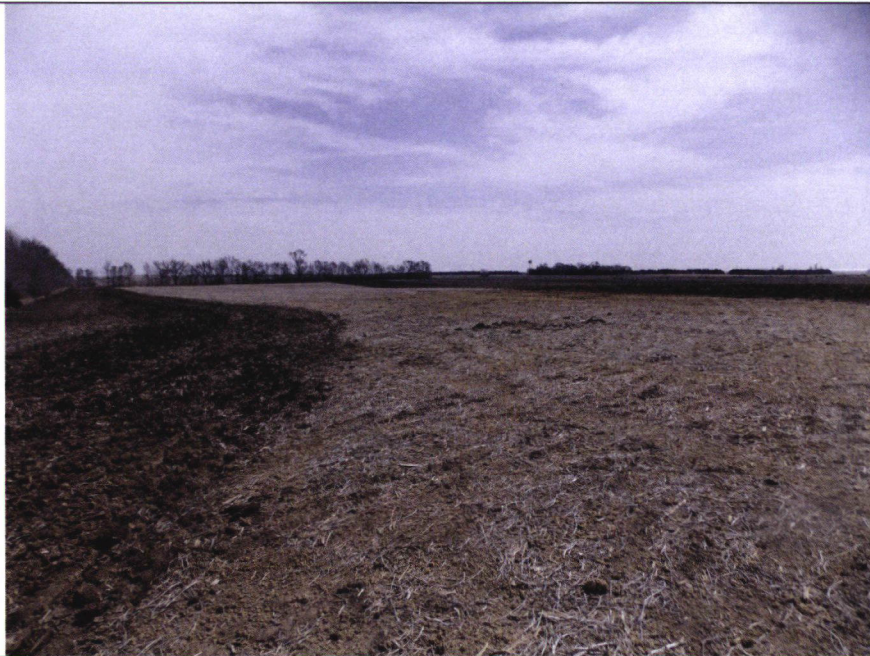
Photograph 14
Date: April 12, 2018
Photographer: Jason Holsten
Camera: Nikon Coolpix L810
IIS# 84069, IWM Permit # NE0204447
NEC# 041018-AB-1328
Subject: AltEn, LLC Site Investigation

Looking east, photograph showing the area of field "B" that had not yet been disked by the farmer. Small clumps of material could be seen spread out over the area.
